# PARTICLE IMPACT DAMAGE IN CERAMICS

TECHNICAL REPORT

March 1979

EFFECTS TECHNOLOGY, INC.  
5383 Hollister Avenue  
Santa Barbara, California 93111

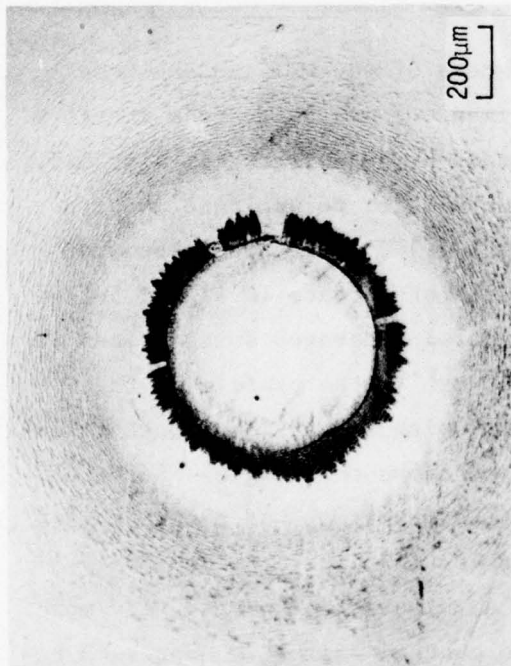
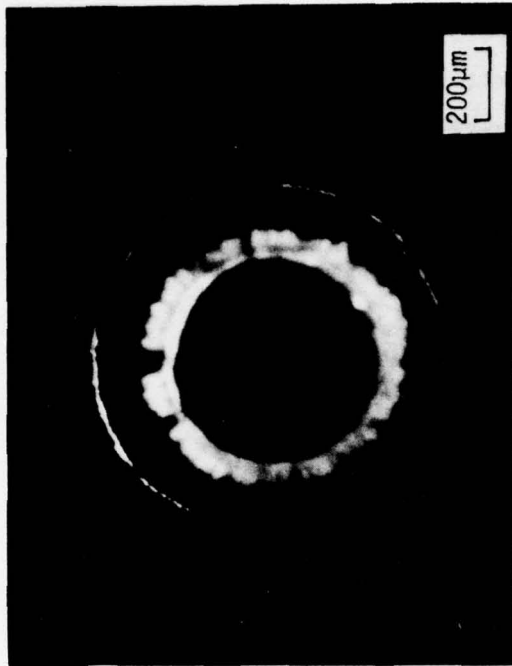
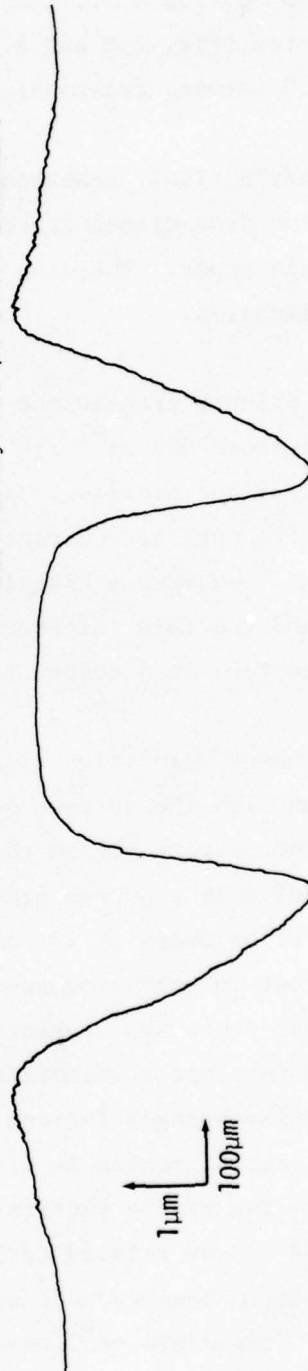
Figure 3.5. 1.6 mm Water Drop Impacting at 476 ms<sup>-1</sup>.

a. Bright field illumination showing surface features.

b. Transmitted light illumination passing through side of specimen. Focused at subsurface fracture array 280 μm below surface.

c. Surface contour along midplane of damage site.

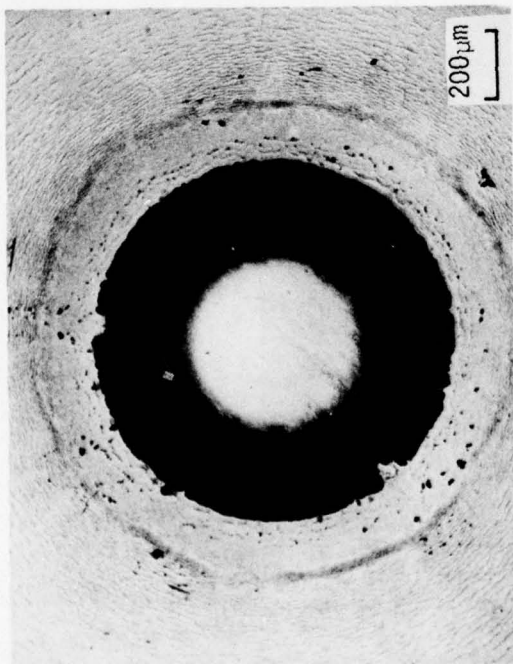
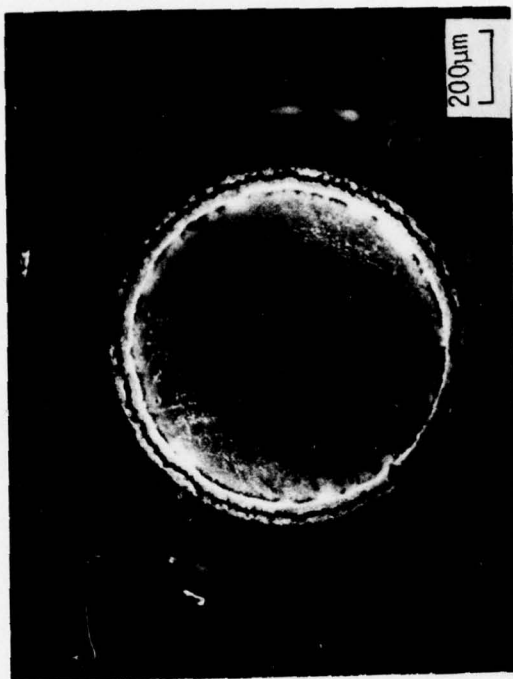
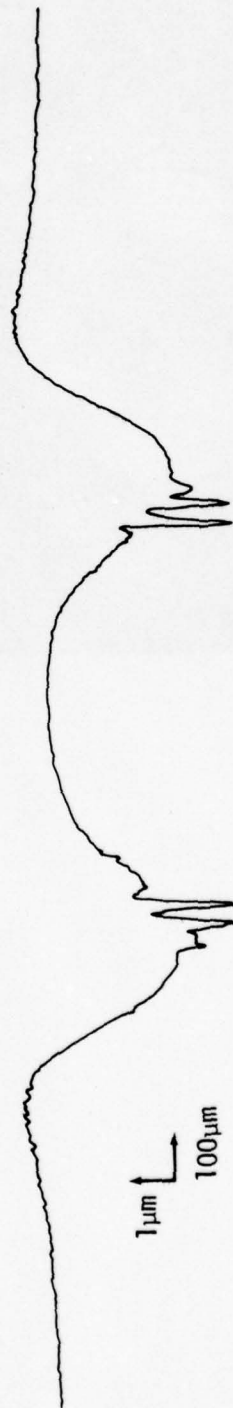
a. Bright field illumination showing surface features. Ring around damage site is due to subsurface fracture array.

b. Side transmitted light illumination. Focused at surface. Overexposed ring at interior of ripple pattern is due to surface ring fracture.

c. Surface contour along midplane of damage site.

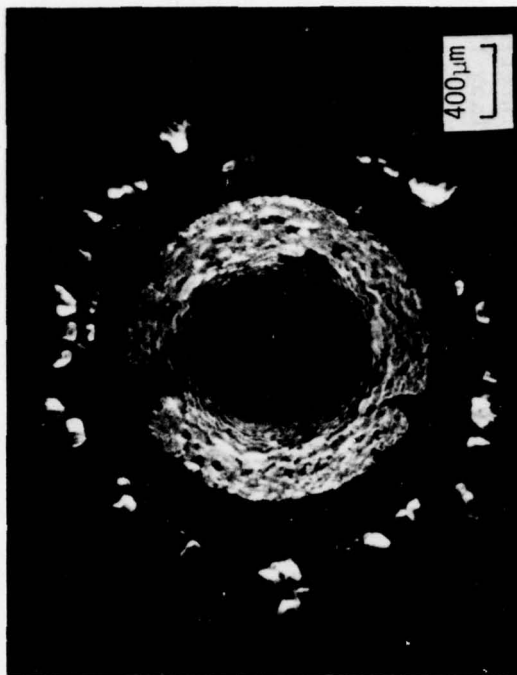
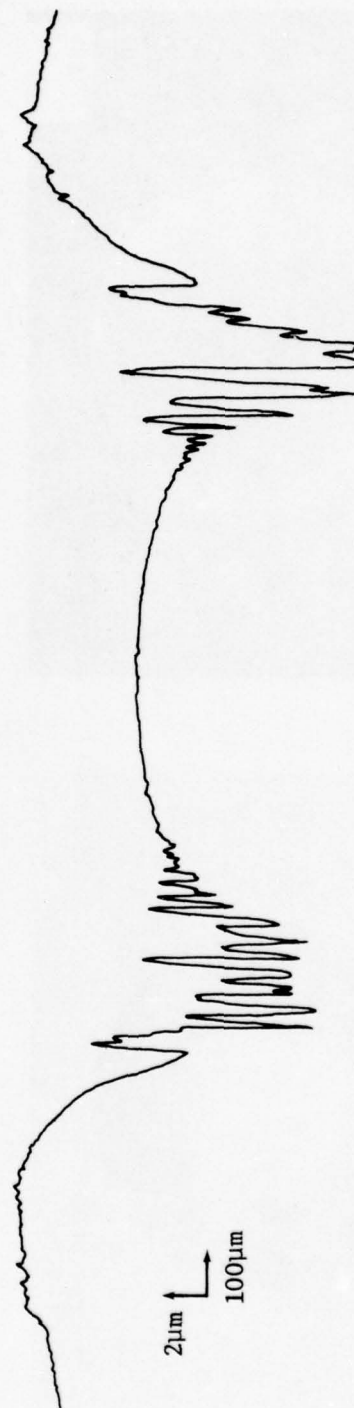
Figure 3.7. 1.9 mm Water Drop Impacting at  $660 \text{ ms}^{-1}$ .

a. Side transmitted light illumination of central damage zone.

b. Surface contour along midplane of damage site.

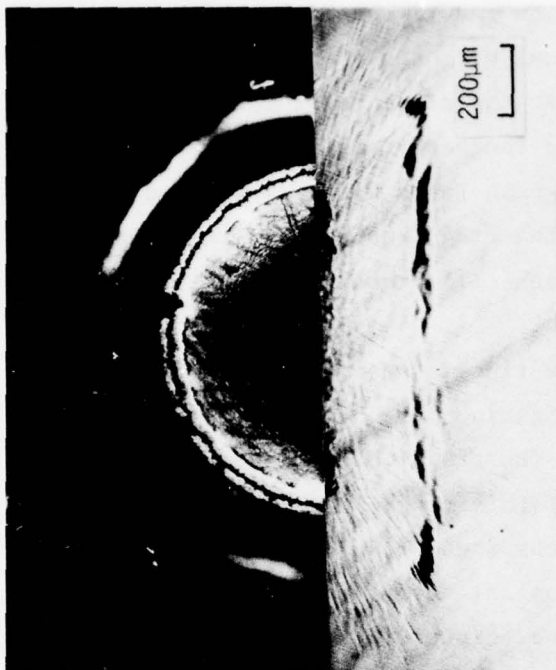
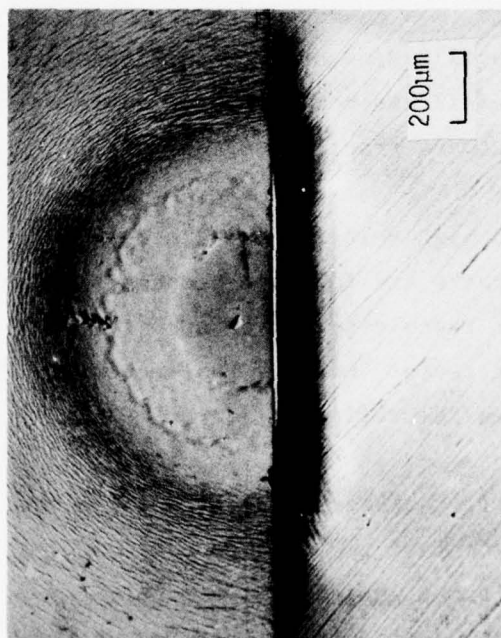
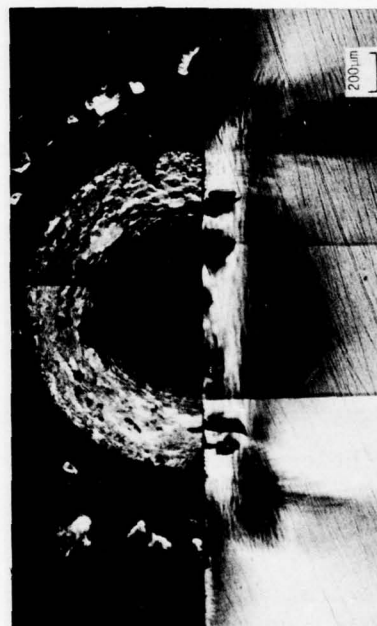
The details of the deformation patterns seen in cross section are difficult to photograph in sufficient contrast to yield good reproductions, however some representative deformation and fracture patterns are shown in Fig. 3.8. The details of the deformation patterns which

a. 1.75 mm water drop impacting at  $394 \text{ ms}^{-1}$ . b. 1.6 mm water drop impacting at  $520 \text{ ms}^{-1}$ .

c. 1.9 mm water drop impacting at  $660 \text{ ms}^{-1}$ .

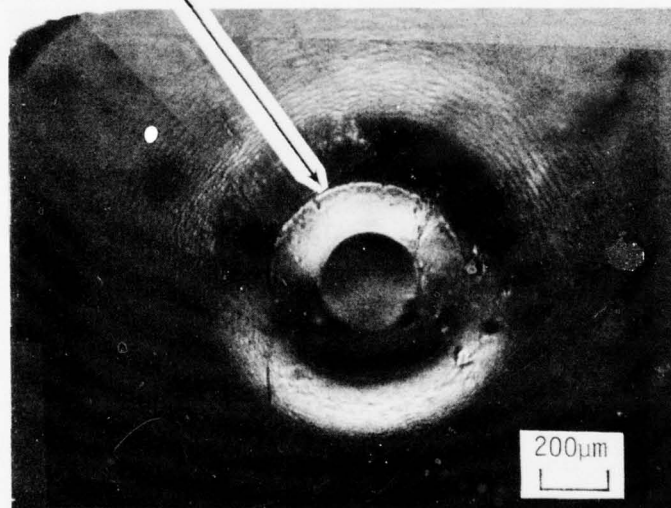
Deformation marking on surface  
in the annular depressed zone.

Figure 3.9. Characteristic Water Drop Impact  
on PMMA at  $300 \text{ ms}^{-1}$  Showing  
Deformation Marking Usually Present.

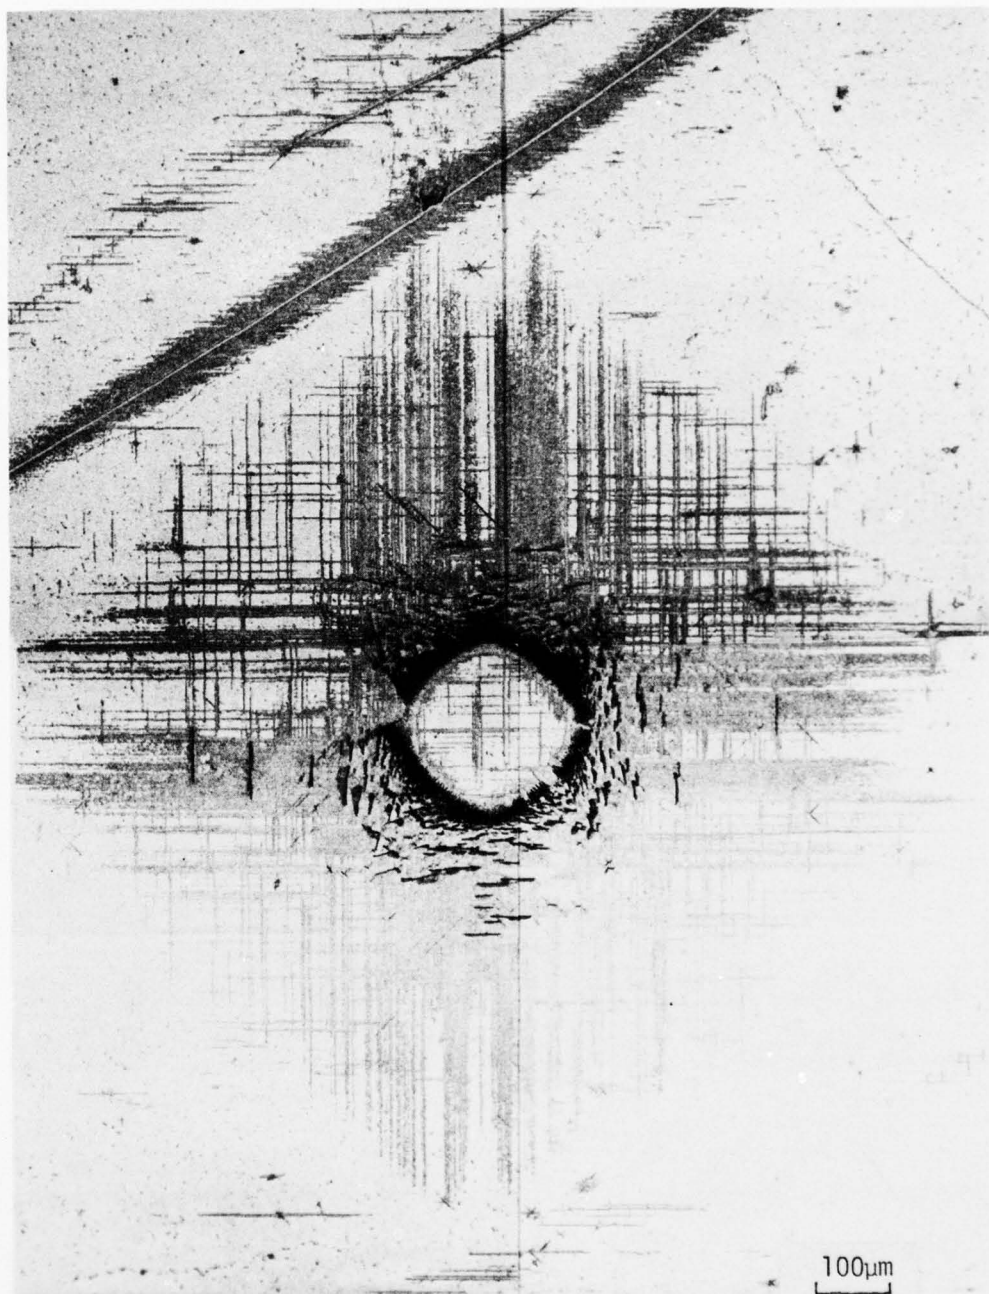
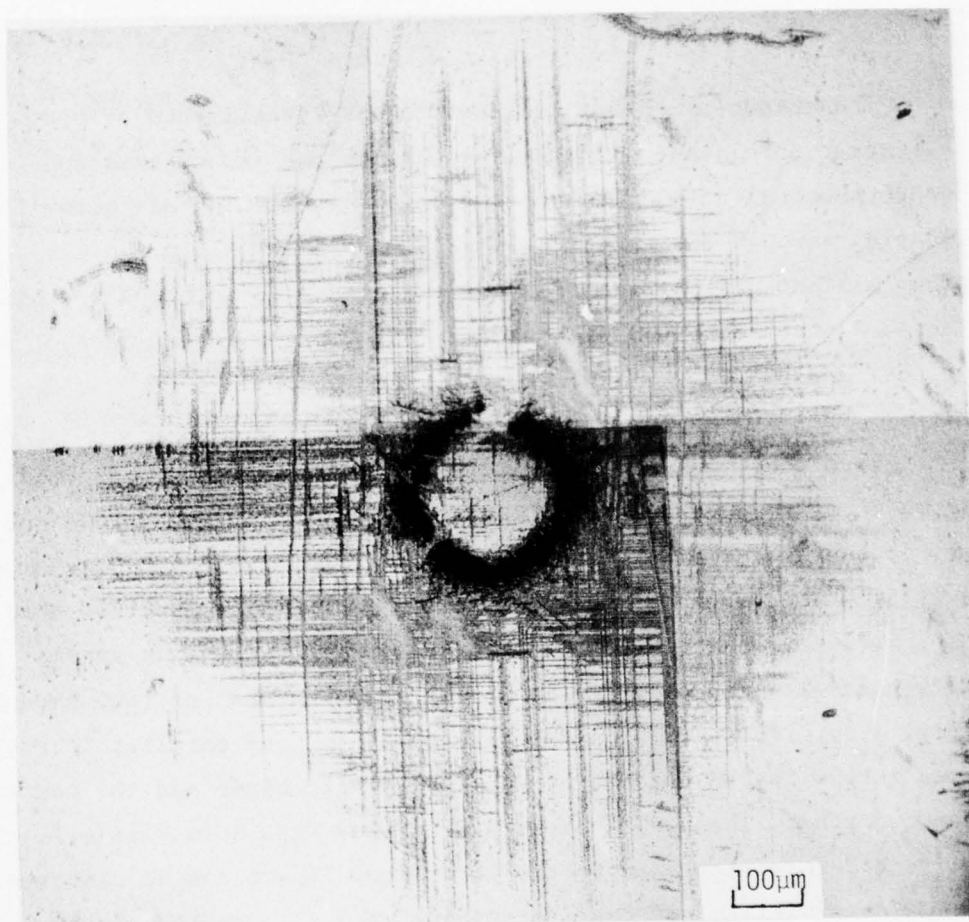
As seen in Fig. 4.5 there is a central region with a very low density of slip referred to as the central undamaged zone. The following descriptions will be made with reference to a right handed coordinate system with the z axis in the impact direction.

a. Shot No. 809 at  $556 \text{ ms}^{-1}$

Figure 4.5. Dislocation Etched Water Drop Impacts  
on (001) Face of MgO.

b. Shot No. 953 at  $563 \text{ ms}^{-1}$ .

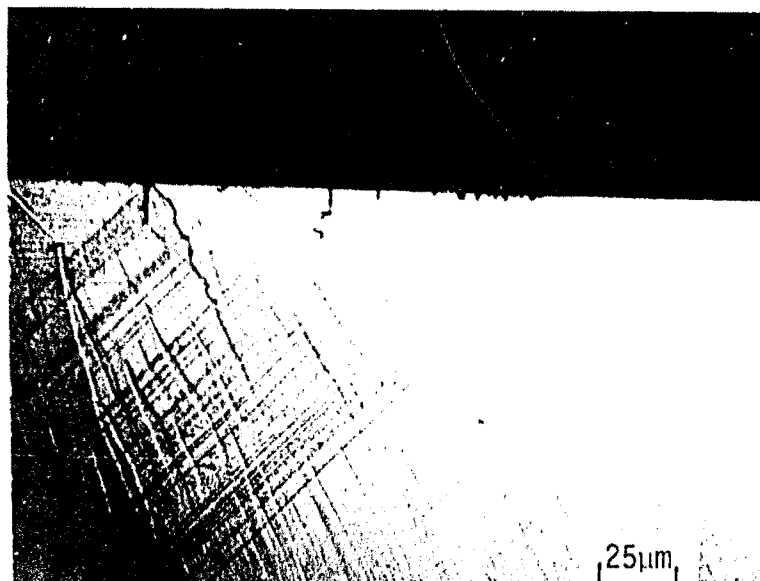
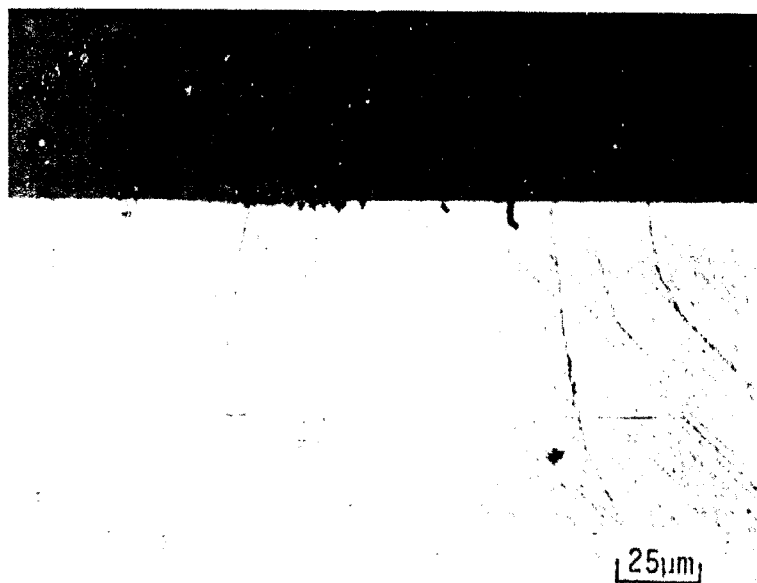
a. Shot No. 953 at  $563 \text{ ms}^{-1}$

b. Shot No. 807 Impacted at  $672 \text{ ms}^{-1}$

Figure 4.9. Etched Cross Section Showing Slip Bands and Fractures In MgO.

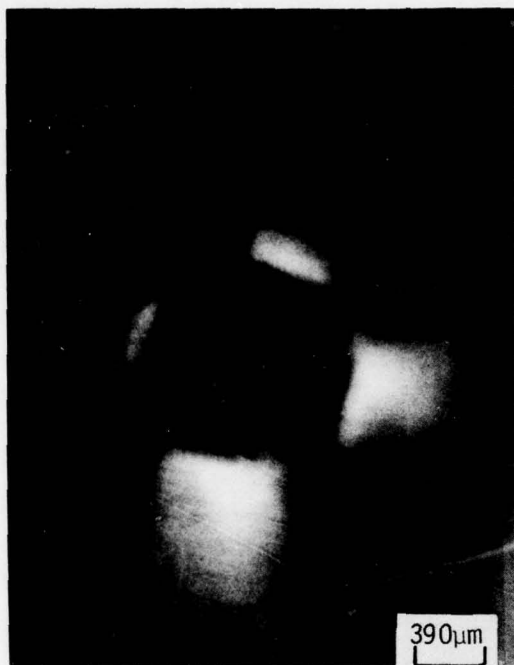
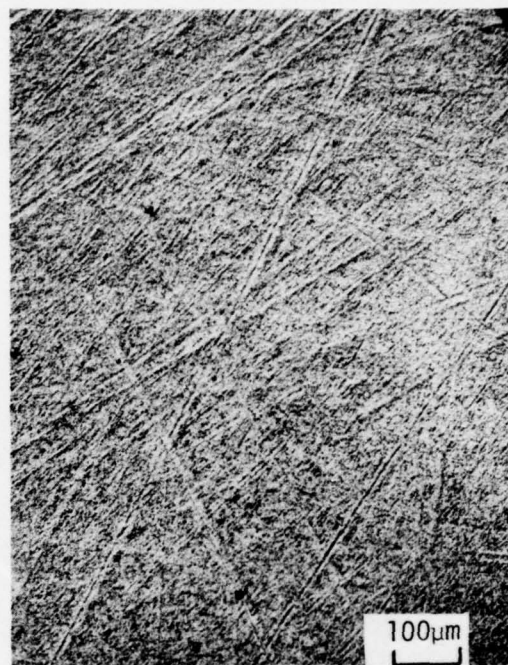
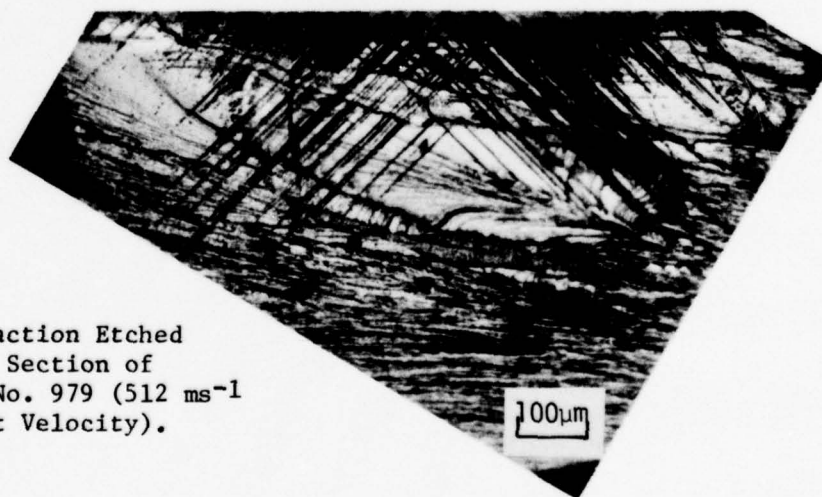
a) Impact Site of Shot No. 1010  
Viewed in Transmitted Polarized  
Light. Impact Velocity  $574 \text{ ms}^{-1}$ .

b) Dislocation Etched Impact Site  
for Shot No. 1010. Note Absence  
of Fracture Annulus.

c) Dislocation Etched  
Cross Section of  
Shot No. 979 ( $512 \text{ ms}^{-1}$   
Impact Velocity).

Figure 4.11. Nature of Water Drop Impact Damage  
on Mechanically-Polished  $\text{MgO}$ .

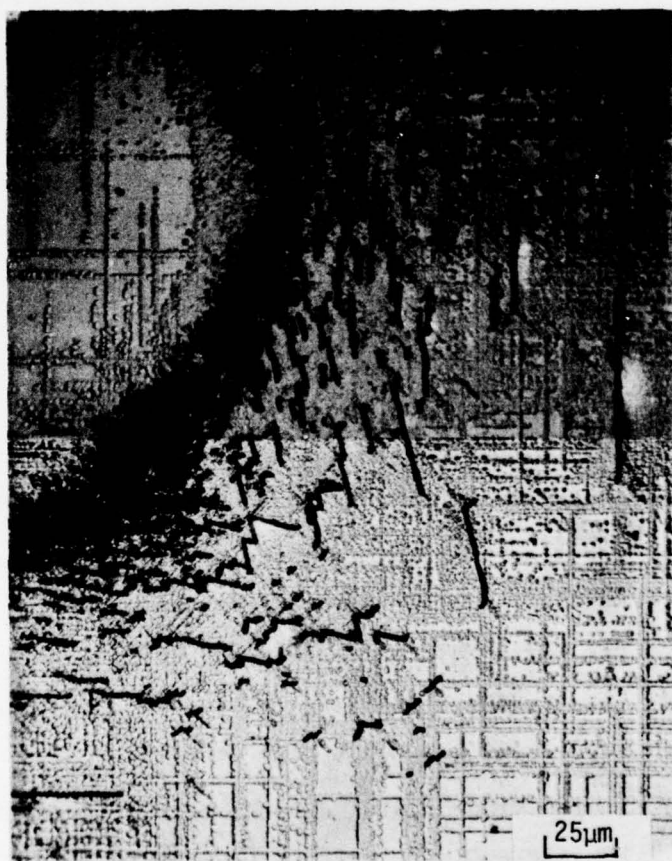
- (i) Due to the four-fold symmetry around the [001] impact axis, the impact damage is similar in eight octants.
- (ii) The fractures exist in an annulus whose inner boundary is approximately square. The diagonals of this square are the [100] and [010] directions.
- (iii) The fractures found at the inner radii tend to be of very short range and high density.
- (iv) In the  $\langle 100 \rangle$  radial directions the larger fractures tend to intersect the surface tangent to the impact annulus.
- (v) The fractures lying near a  $\langle 110 \rangle$  radial direction are of two types: (1) those whose intersection with the (001) impact face is tangent to the impact; (2) those that are apparent distortions in a radial direction of the fractures in (ii). Intersections of these radially distorted fractures from two quadrants form the W-shaped fractures seen in Fig. 4.13.

Figure 4.13. Inner Region of One Quadrant of Figure 4.5.

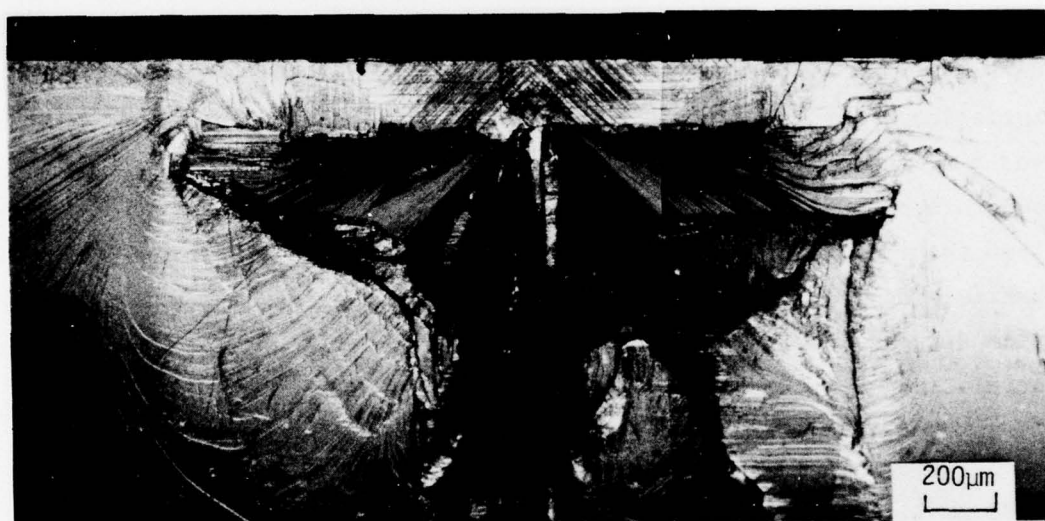
A nylon bead impact at  $1000 \text{ ms}^{-1}$  on MgO has been described by Hooker and Adler (1978) in some detail. Fig. 4.16 is an etched cross section of the impact. The large wing-like structures are fractures caused by the impact. Close observation of these reveals two distinct origins of fracture (one for each wing). The origins are at the position which in a water drop impact is at the intersection of the Type A

Figure 4.16. Cross Section of Nylon Bead Impact  
at  $1000 \text{ ms}^{-1}$  on (001) MgO.

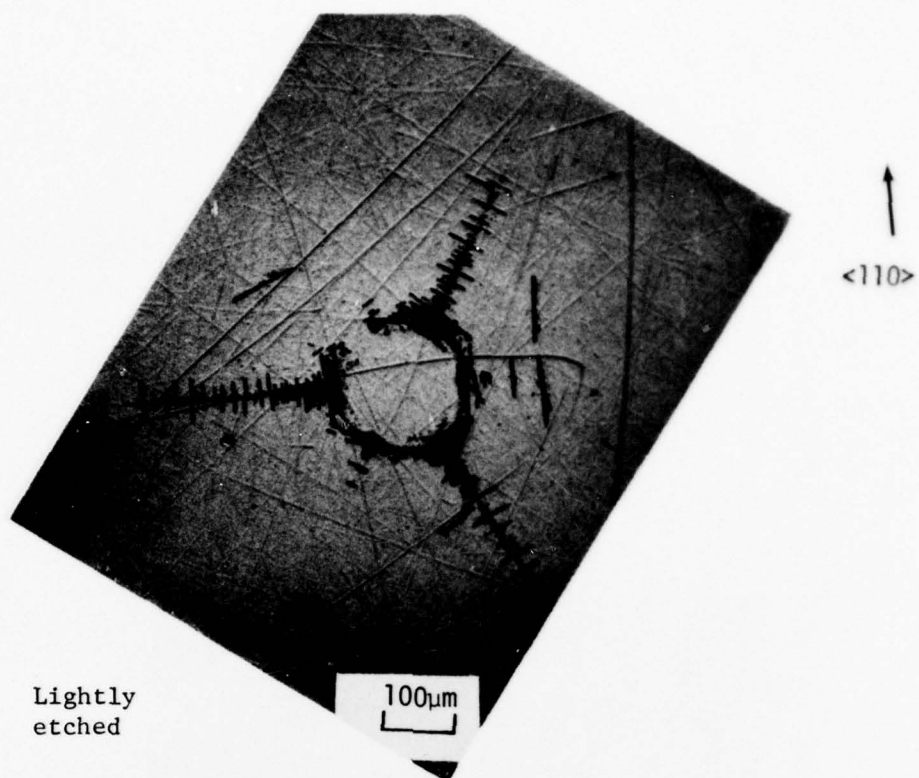
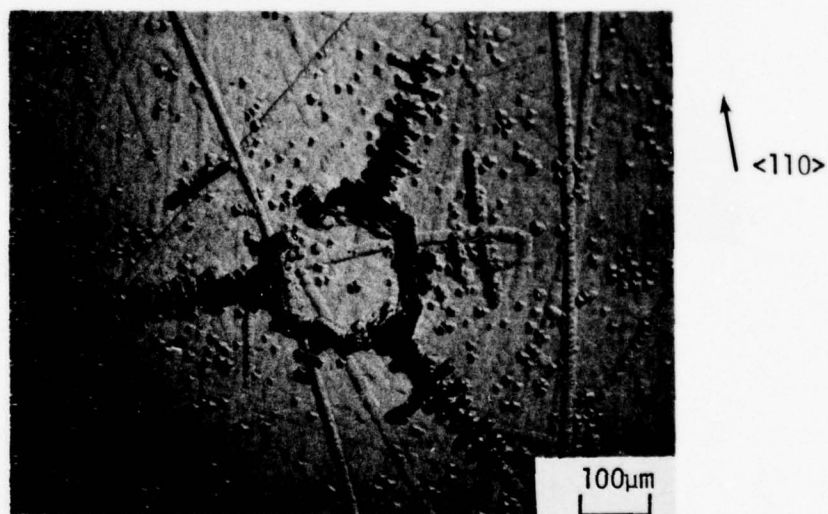
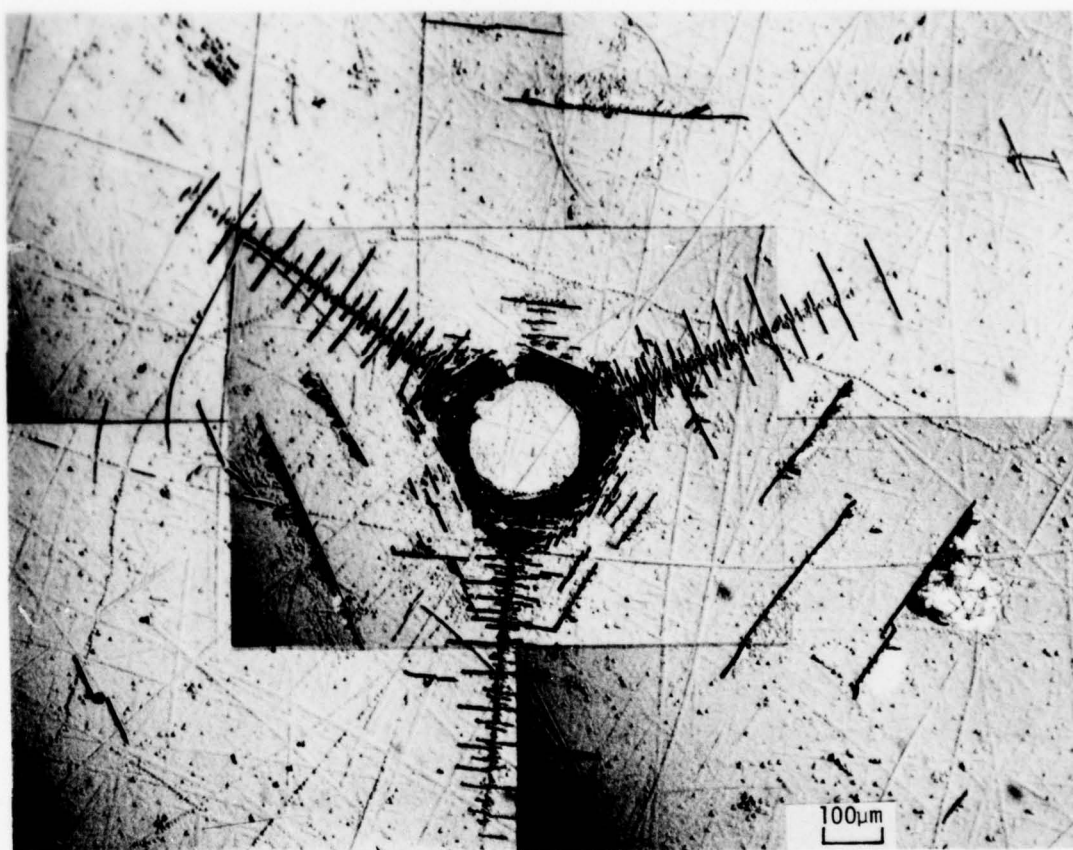
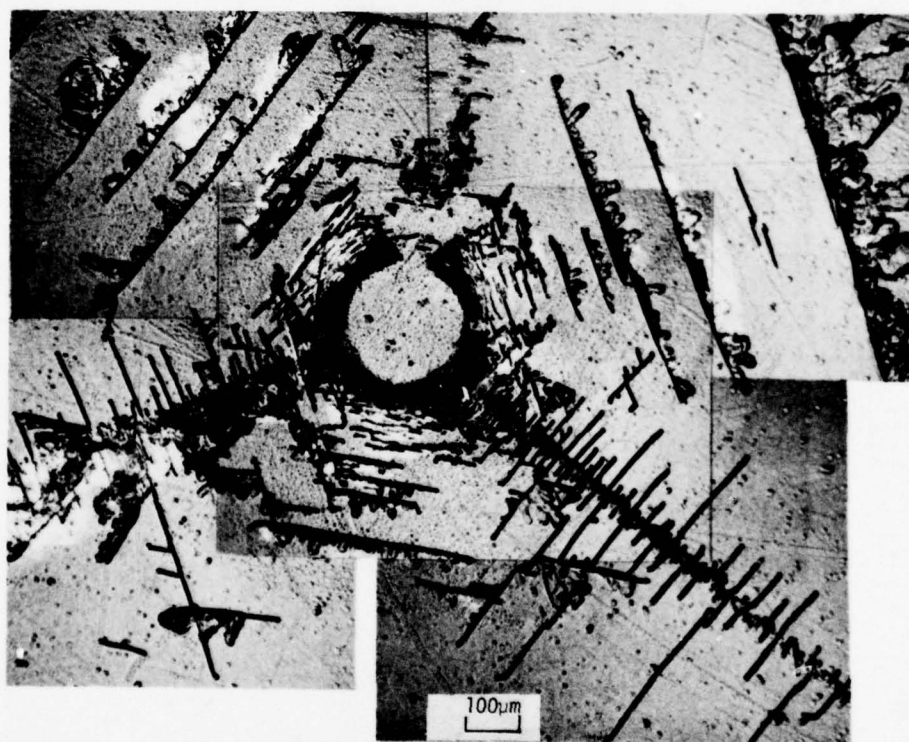
Dislocation etched impact sites for impact velocities of 307 ms<sup>-1</sup>, 404 ms<sup>-1</sup>, and 521 ms<sup>-1</sup> are shown in Fig. 4.18. It is immediately apparent that in comparison to (100) MgO that (111) CaF<sub>2</sub> exhibits much less dislocation slip band activity and that impacts at 307 ms<sup>-1</sup> have considerably fewer dislocation etch pits than impacts at 521 ms<sup>-1</sup>. In addition to having less dislocation activity the dislocations present are either loosely organized into slip bands or isolated.

a) Shot No. 995 at  $307 \text{ ms}^{-1}$

Figure 4.18. Dislocation Etched {111} Impacts on  $\text{CaF}_2$ .

$\angle 110^\circ$       b. Shot No. 947 at  $404 \text{ ms}^{-1}$ .

c. Shot No. 975 at  $512 \text{ ms}^{-1}$ .

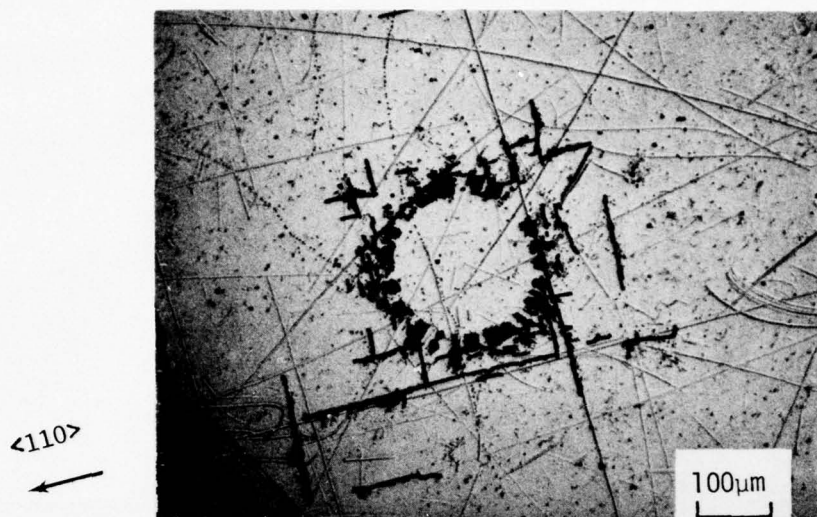
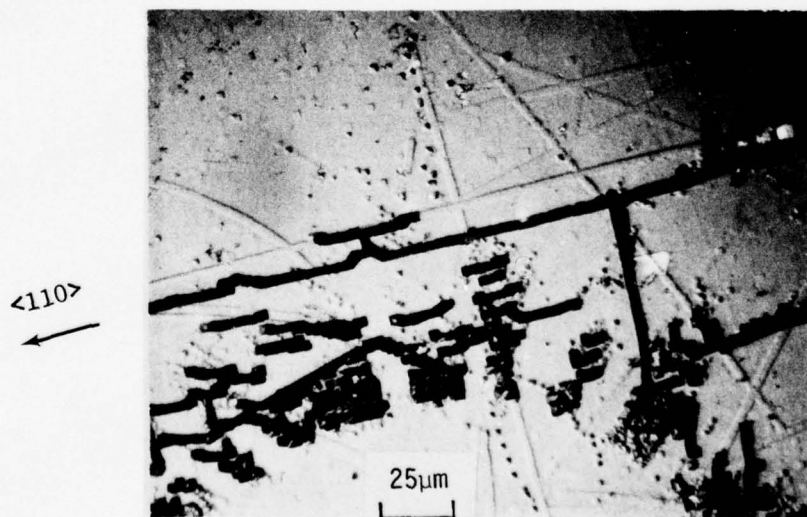
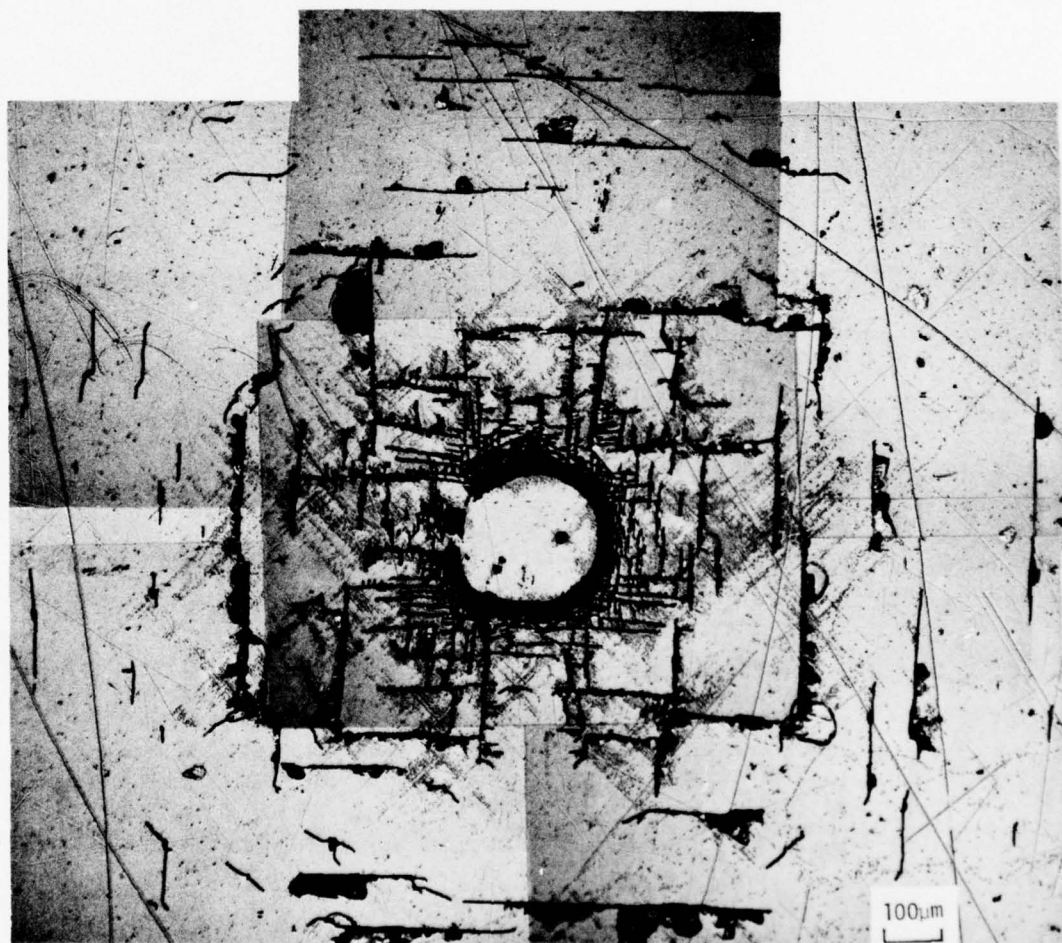
a) Shot No. 999 at  $332 \text{ ms}^{-1}$

Figure 4.20. Dislocation Etched {100} Impacts on  $\text{CaF}_2$ .

b. Shot No. 987 at  $528 \text{ ms}^{-1}$ .

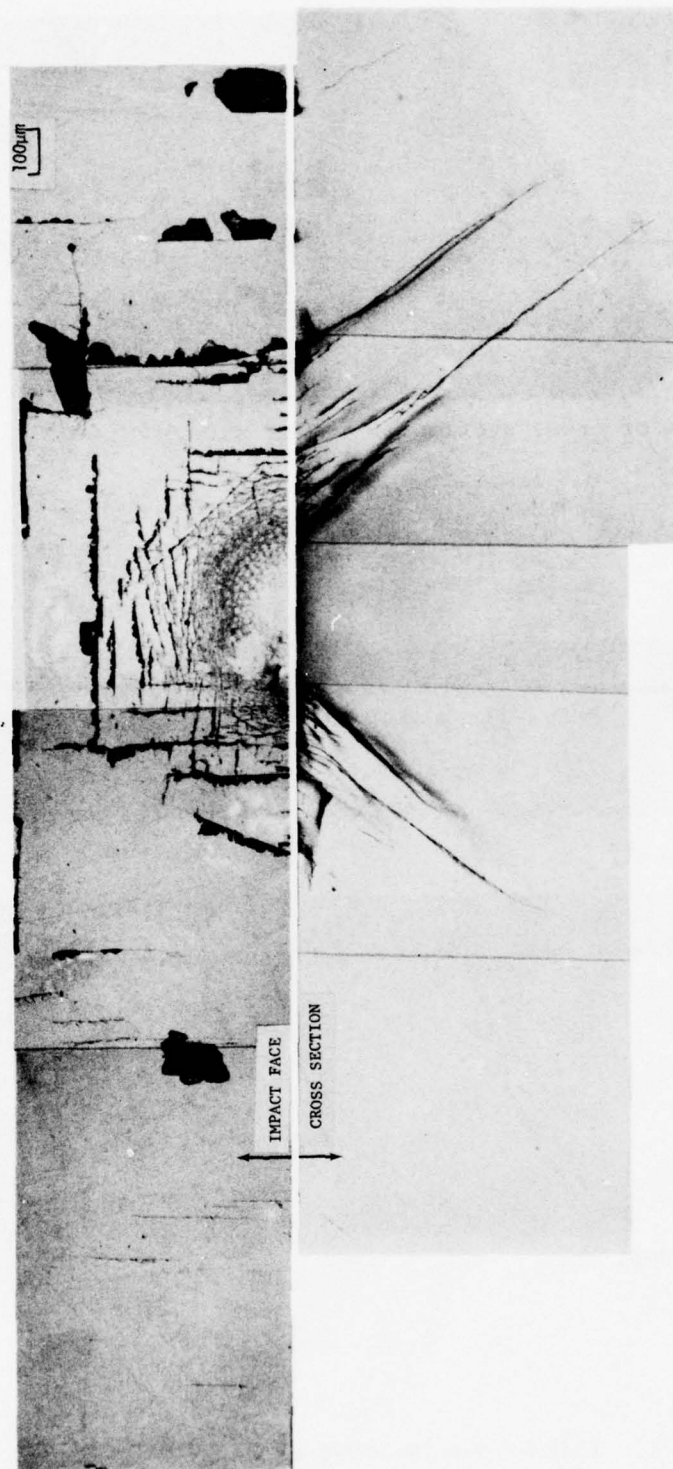
Figure 4.22. (100) Cross Section of a Water Drop Impacting at  $548 \text{ ms}^{-1}$   
(Shot no. 914) on (001)  $\text{CaF}_2$ .

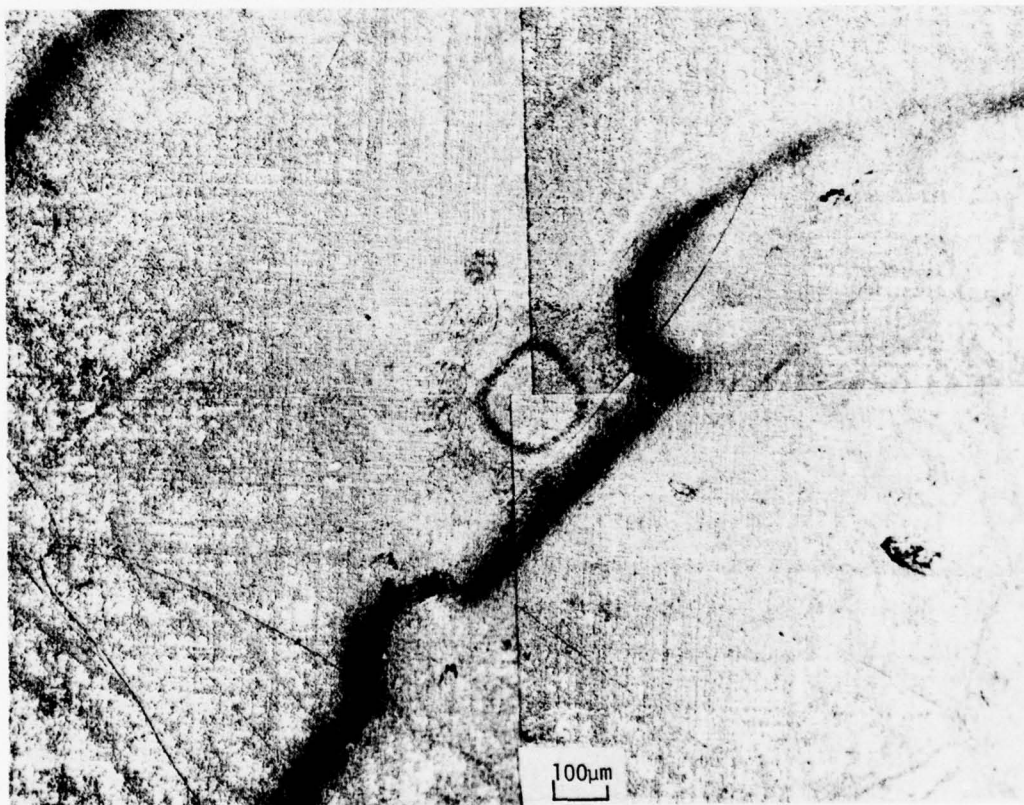
Figure 4.24. Dislocation Etched Water Drop Impact on (001) LiF at  $385 \text{ ms}^{-1}$  (Shot no. 980). (The dark band is the remnants of a chemically polished cleavage step.)

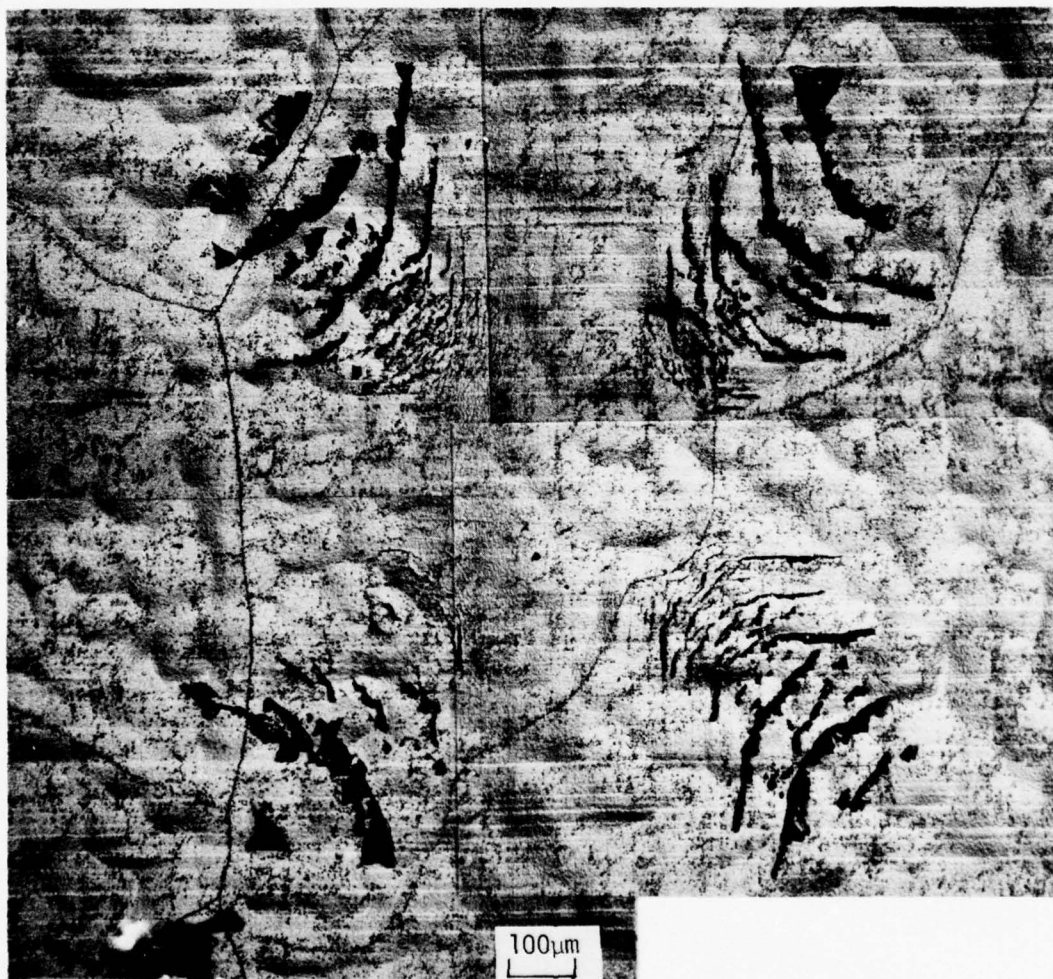
Figure 4.26. Unetched Water Drop Impact on (001) LiF at  $555 \text{ ms}^{-1}$  (Shot no. 915).

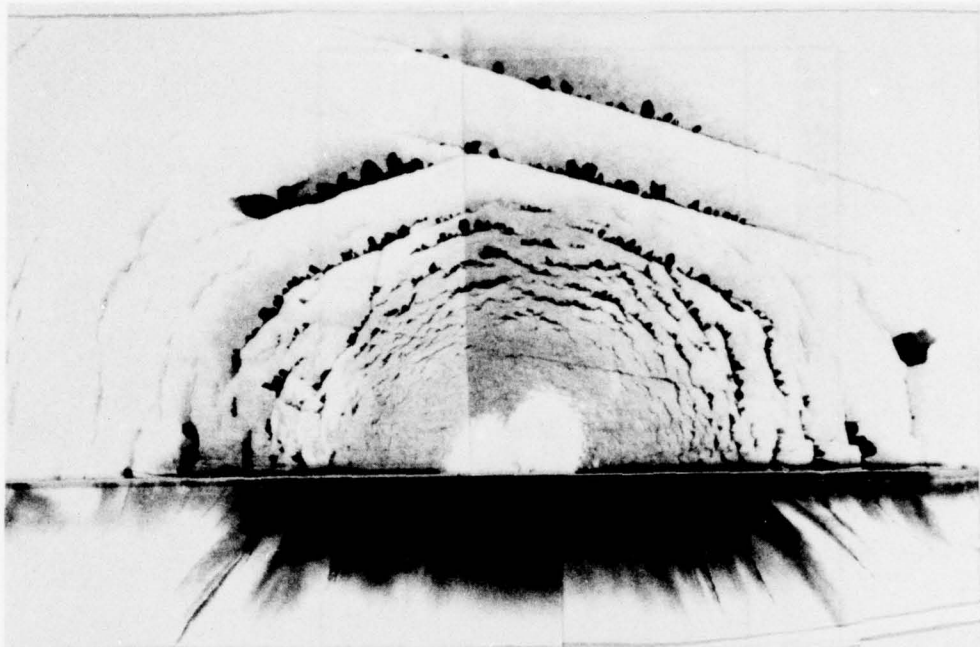
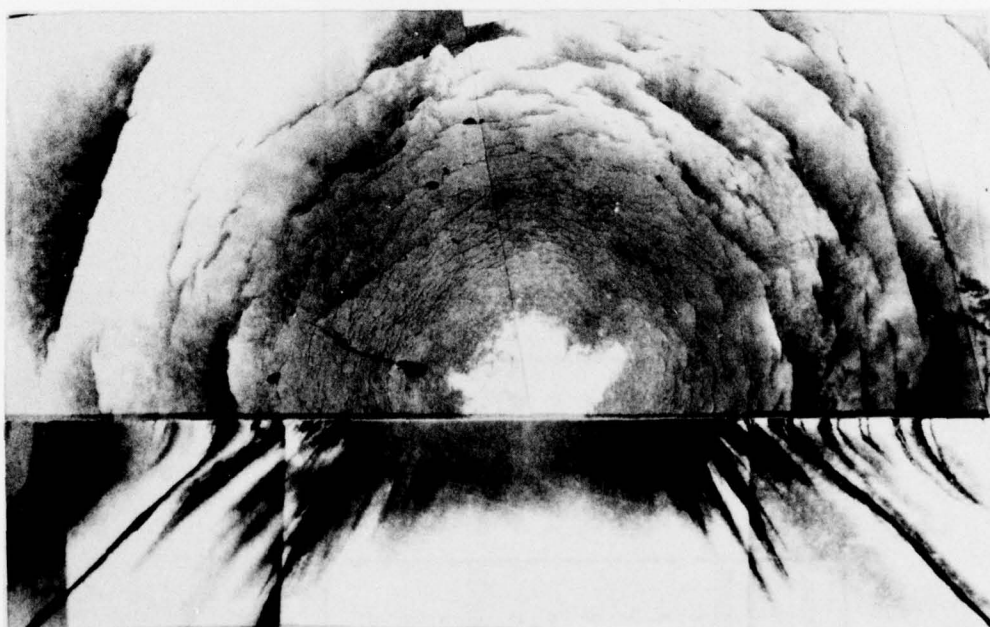
(a) 1.78 mm Water Drop Impact at  $518 \text{ ms}^{-1}$  (Shot No. A5)

(b) 2 mm Nylon Bead Impact at  $550 \text{ ms}^{-1}$  (Shot No. N3)
